# Polishing the Ferrules

Howard Budd  
Sep 13 2007

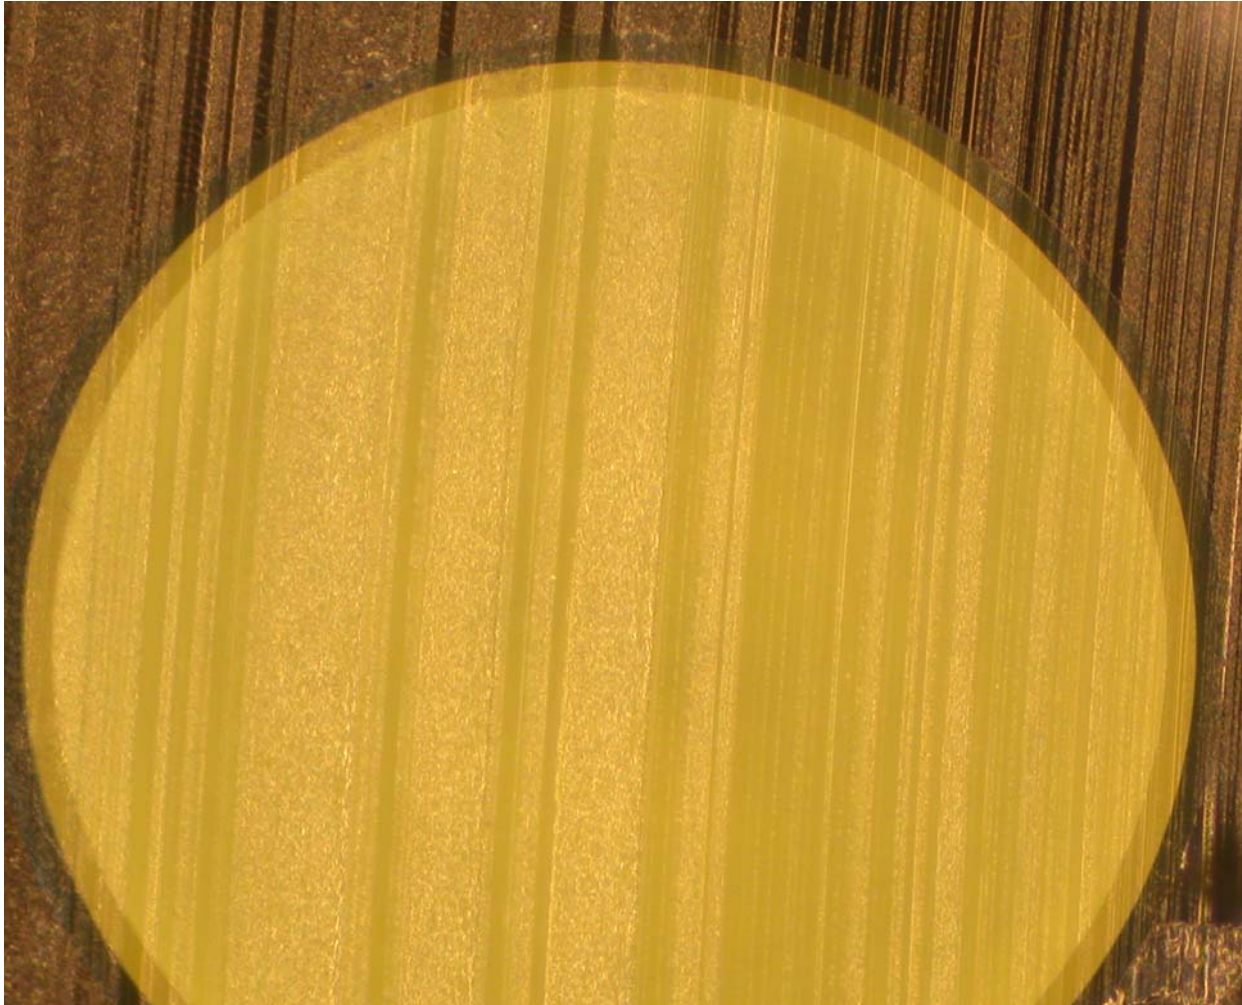
- We cut the WLS fiber in the back of the this pigtail to try to get the illumination from the from
  - We don't have any clear 1mm fiber
- Diamond seems to have sustained some damage

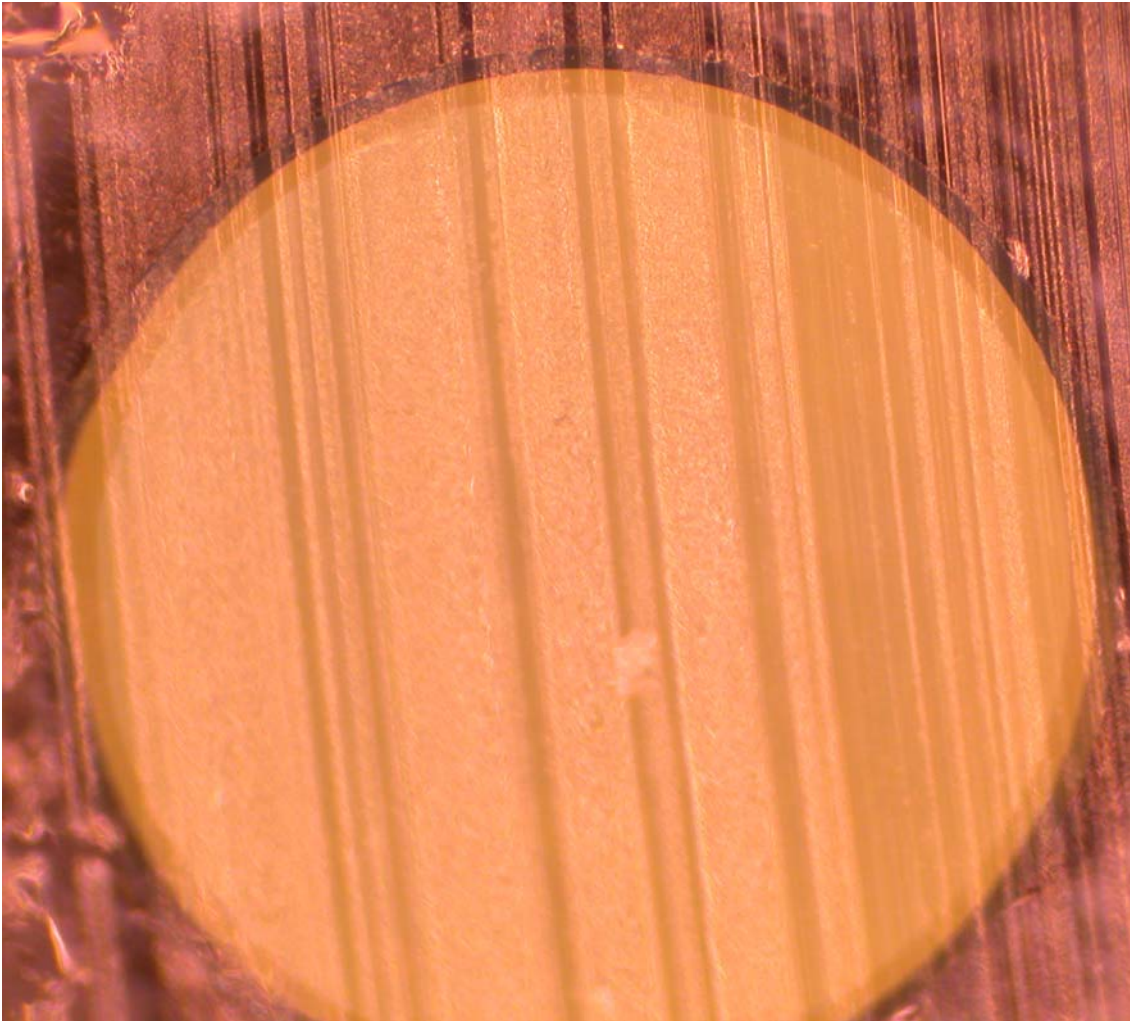
- Diamond damage seen
