# Optical acceptance of the DDK connectors or What exactly do you mean by transmission?

Howard Budd

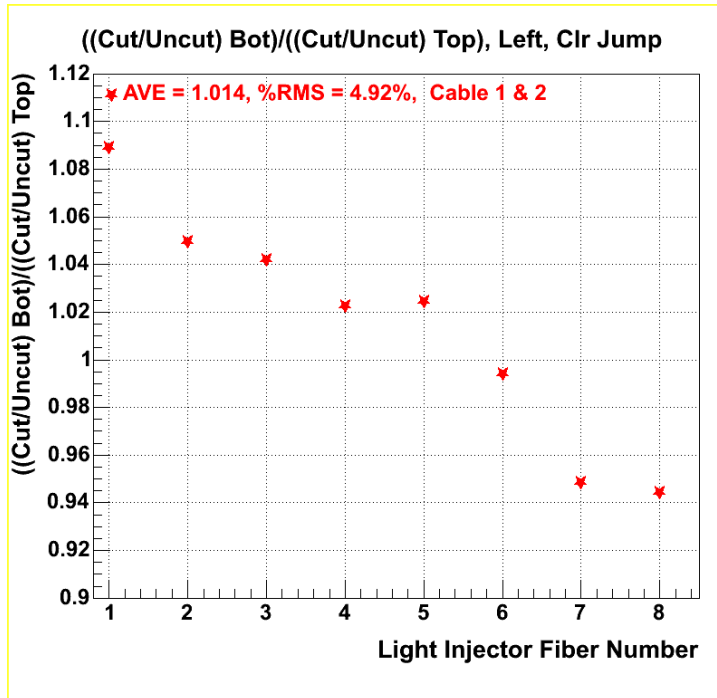
# Cut & Uncut Cables Top and Bottom

- ◆  $\frac{((\text{bottom 2 1m cables})/(\text{Bot 2 m cable}))}{((\text{top 2 1m cables})/(\text{top 2 m cable}))}$
- ◆  $(2 \text{ 1m cable})/(2\text{m cable})$  is like a transmission = (cut/uncut)
- ◆ Transmission measured in the bottom connector is not the same transmission measured in the top connector
- ◆ Transmission is a function of the light injector fiber number
- ◆ Looks like it's the problem is measurement not the connectors

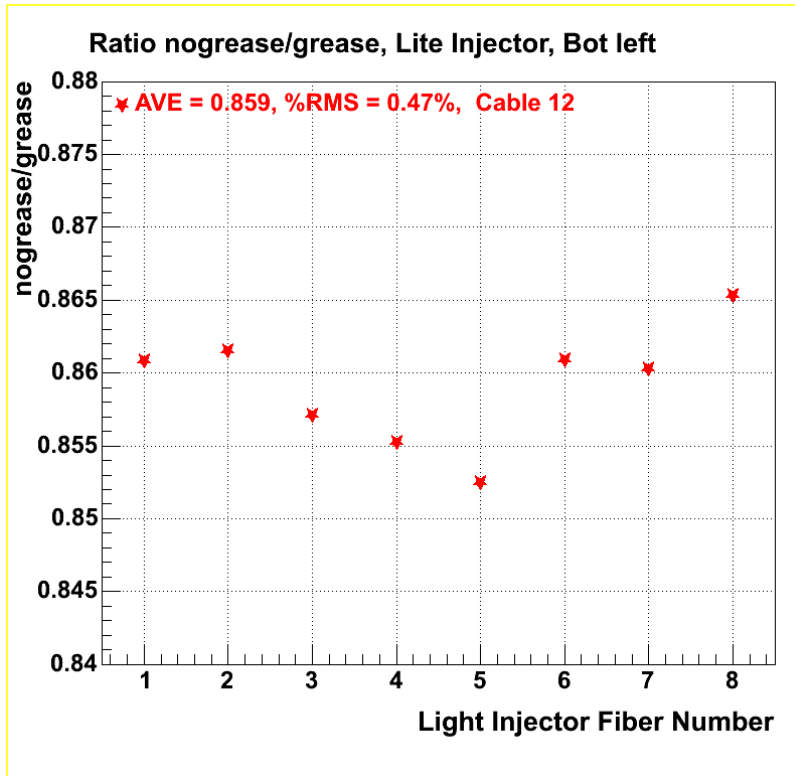
# Can We Explain This Effect?

- ◆ If the light angular distributions, the modes, are different then the different reflections at the connector interface may be causing the effect.
- ◆ We can test this by putting grease in the connector
- ◆ The grease removes the differences in index of refraction across the gap
- ◆ The increase in transmission, about 16%, is independent of the fiber number
- ◆ Note that the transmission for injector fiber 1 for this cable is 86%, so roughly all the light is being transmitted with grease
  - ◆ However, there is some error in this because the clear pigtail had to be replaced between the transmission test and this test

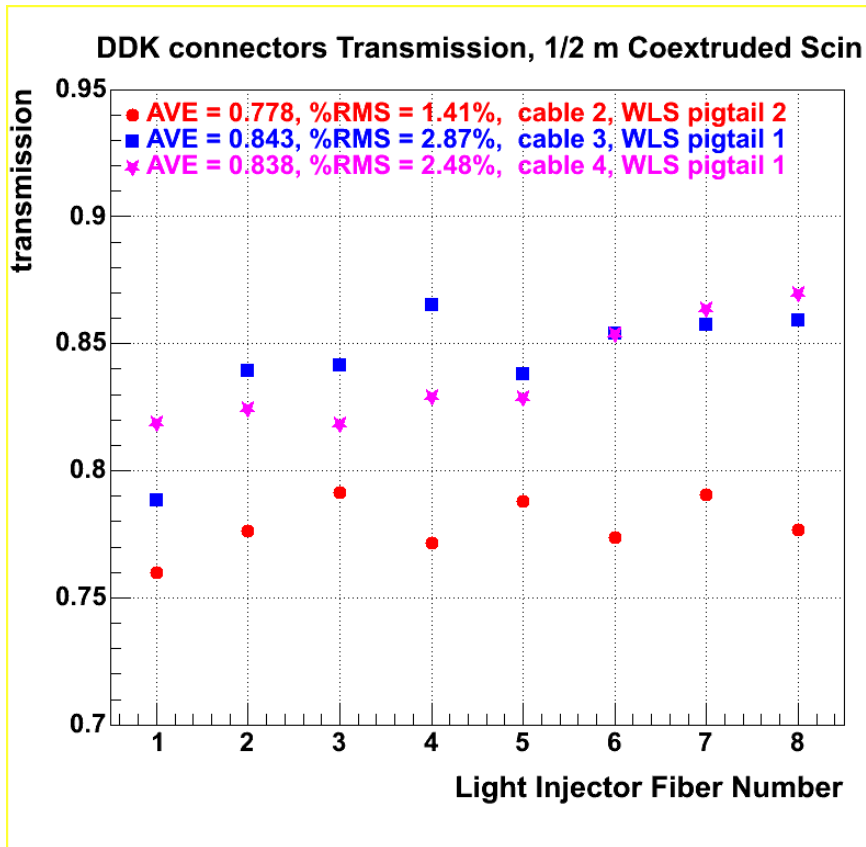
# Transmission Using Coextruded Scin

- ◆ Ave = 82% and fairly independent of hole number.
- ◆ The result for the 2 pigtails seem to be different
  - ◆ Not sure why they should be different but maybe not enough measurements to tell

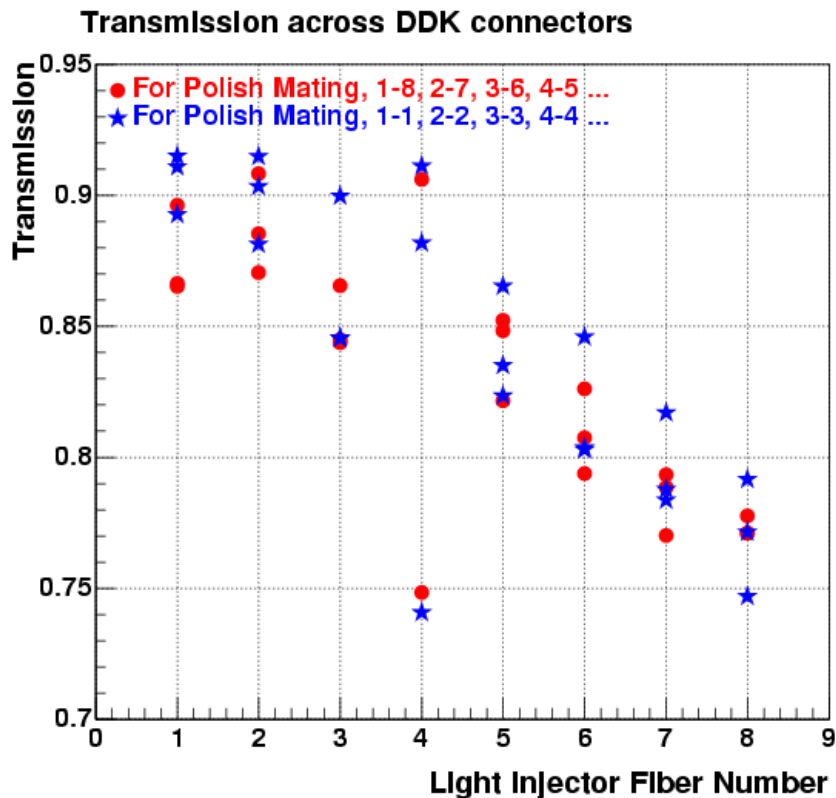
# Polishing direction holes 1-8 & 8-1

- ◆ The Connectors near the light injector box are polished with the same orientation
- ◆ The connectors shown in the red points are polished with the same orientation,
  - ◆ This means 1st hole polished matches with the 8 th hole polished...
- ◆ The connectors shown in blue points are polished with the opposite orientation to their mate
  - ◆ 1<sup>st</sup> fibers polished mate together ...
- ◆ Polishing is not the problem
- ◆ (Fiber 4 is bad in the clear pigtail)
